# Manhole Inspection Summary

Manhole # S45E\_\_021MH

Insp Date: **7/23/08 9:57 AM**

**Location** Address: **1801 baltime lombard**

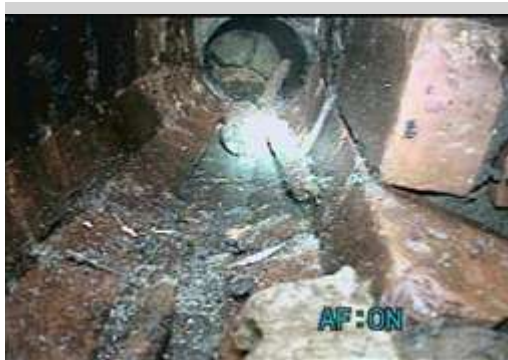
Defect 4

Channel Exposure: **Fully Open** Junc Dist: **0** nearest .5 ft. Azimuth: **0**

channel debris

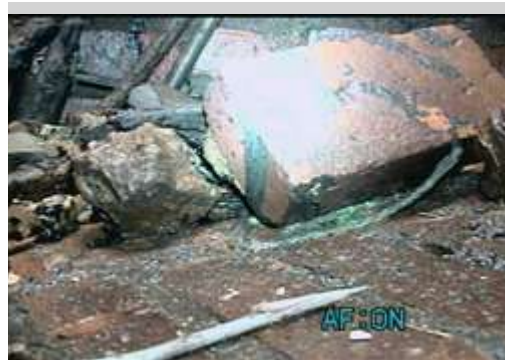
Defect 2

Condition: ☐ Sound ☐ Cracked ☐ Root Intrusion ☐ Deteriorated ☐ Leaks ☒ **Debris**

bench debris

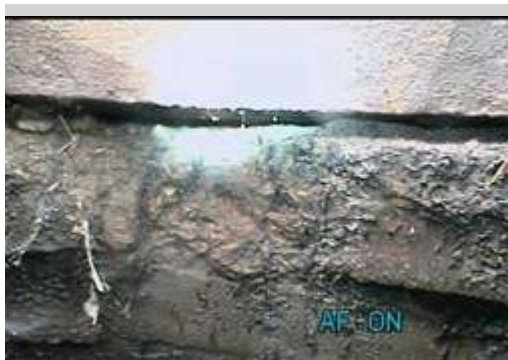
Defect 1

Condition: ☐ Sound ☒ **Cracked** ☐ Root Intrusion ☐ Loose Brick ☐ Deteriorated

corbel cracked

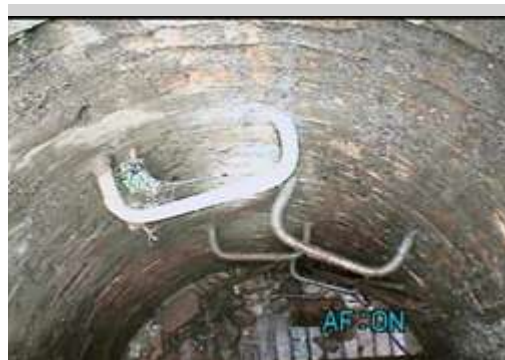
**Steps** Count: **4** Missing: **0** ☒ **Corroded**

corroded steps

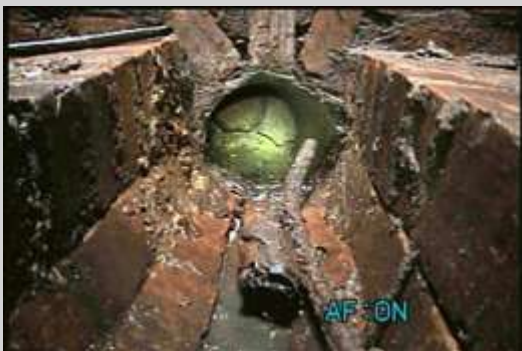
6 O'Clock Inflow

blocked

Deposits: ☐ None ☐ Mud ☒ **Sludge** ☐ Debris ☐ Grease

Silt Depth: 0 (in.) Deposits Extent: **Heavy**
